Kleenmaid Induction Cooktop Warranty Service

9 March 2017

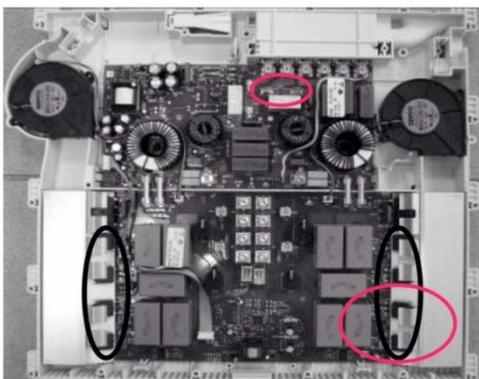
The printed fuse at the top of the board had failed (F101). The issue I feel is that the triacs on the power board had failed. I was getting readings of 0 ohms and approximately 9 ohms from the outer two legs to the middle legs. All other triacs were reading greater than 10K ohm as required including those on the smaller board. The two triacs that had failed were on the right hand side of the board on the bottom. I'm referencing this orientation from your service guide that we have for this unit. See attachment, red markings.
